Manhole Inspection Summary

Manhole # S41QQ_007MH

Insp Date: **2/20/07 1:37 PM**

Location Address: **901 CECIL AVE**

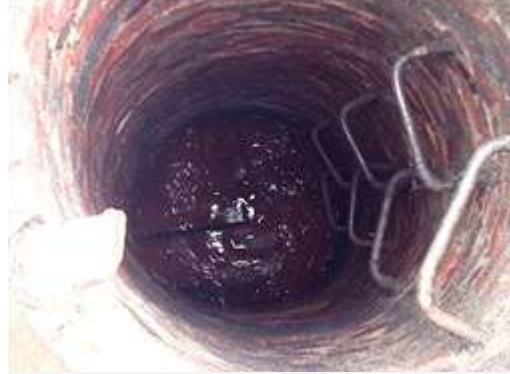
Top View

Barrel infiltration. Bench and Channel debris.

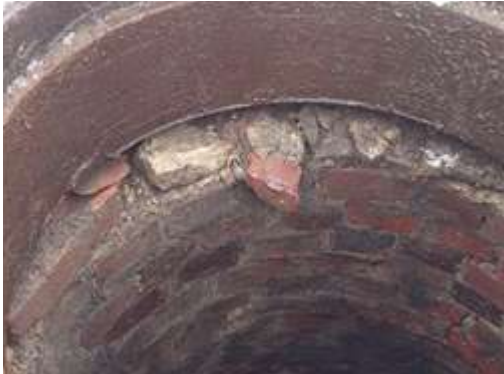
Defect

Frame leaks. Frame offset. Adjustment deterioration, loose brick and infiltration. Corbel infiltration.

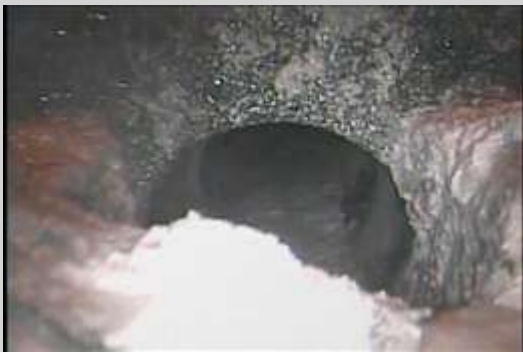
8 in. Circular Gravity Sewer Pipe Out @ 12 O'Clock

Deposits: ☐ None ☒ **Mud** ☐ Sludge ☐ **Debris** ☒ **Grease**

Silt Depth: **0** (in.) Deposits Extent: **Light**

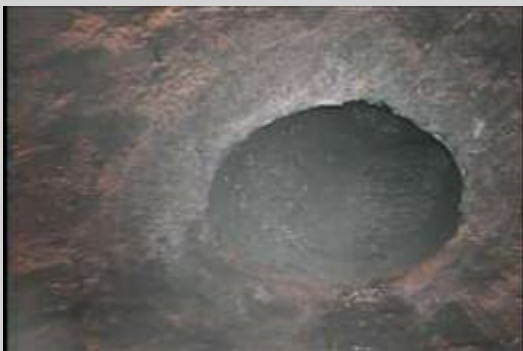
8 in. Circular Gravity Sewer Pipe In @ 6 O'Clock

Deposits: ☐ None ☐ Mud ☐ Sludge ☒ **Debris** ☒ **Grease**

Silt Depth: **5** (in.) Deposits Extent: **Heavy**

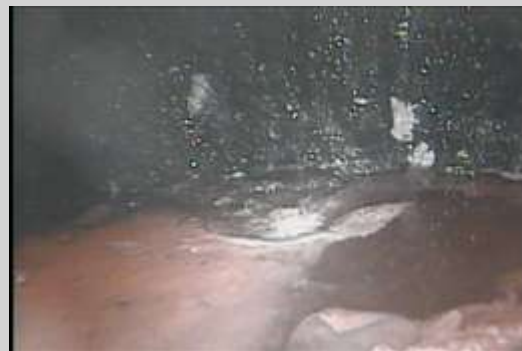
Drop In @ 6 O'Clock

Drop Condition: **Partly Clogged**
